FURTHER STUDIES OF ATCRBS BASED ON  
ARTS-III DERIVED DATA

A. G. Cameron

Massachusetts Institute of Technology

1. Report No. FAA-RD-74-145	2. Government Accession No.	3. Recipient's Catalog No.	
4. Title and Subtitle Further Studies of ATCRBS Based on ARTS-III Derived Data		5. Report Date 13 December 1974

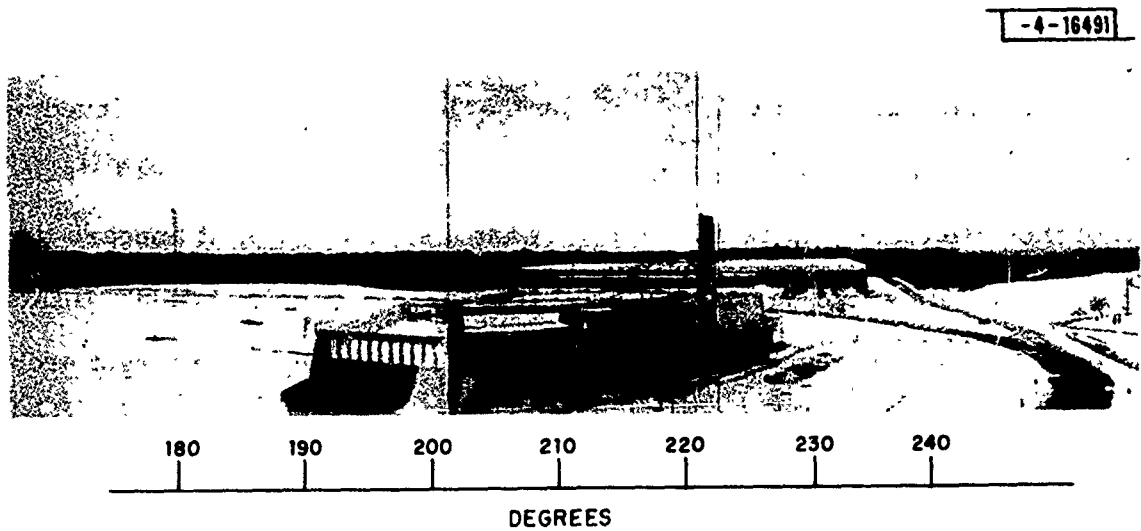
Fig. 5. Southerly sector of panoramic photograph taken from Suitland, MD. ARSR.

Upon completion of the false target analysis, discussions were held with Washington ARTCC and ECAC personnel about the surroundings of the radar. They noted, and a subsequent panoramic photo confirmed, that there is indeed a building at close range to the south, whose shape fits the pattern

The incinerator building looks to be about 150 ft long; it would certainly be possible to modify its surface to cure the reflection problem it causes. Modifications of this sort would undoubtedly alter the lines of the building substantially. The other building, on the other hand, appears quite long, and probably prohibitively expensive to modify.

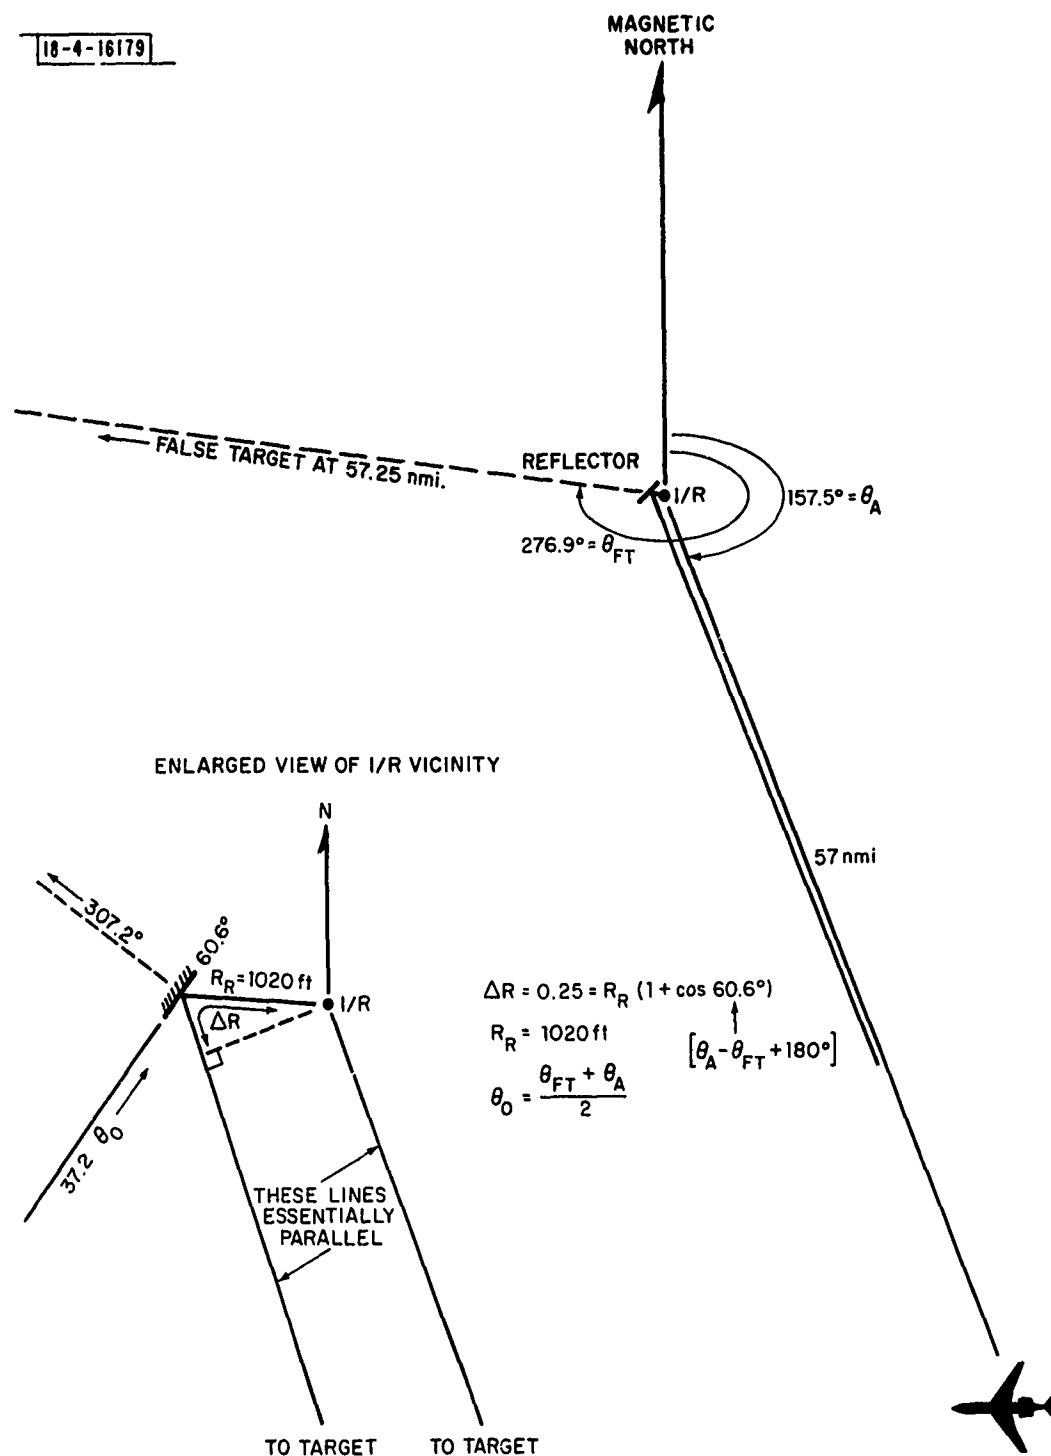
Fig. 11. Simplified geometry  $R_A \gg R_R$ .

These assumptions appear quite appropriate for the particular situation at Albuquerque. Should they prove undesirable in other applications, it is fairly straightforward to remove their effects from the algorithm. The basic false target elimination algorithm is first described in general terms, and then specifically tailored to the Albuquerque situation. The process involves recognition of aircraft in regions where they can cause false targets, calculation on where those targets would be, search of those areas to see if correlated targets are present, and identification of those targets as false.

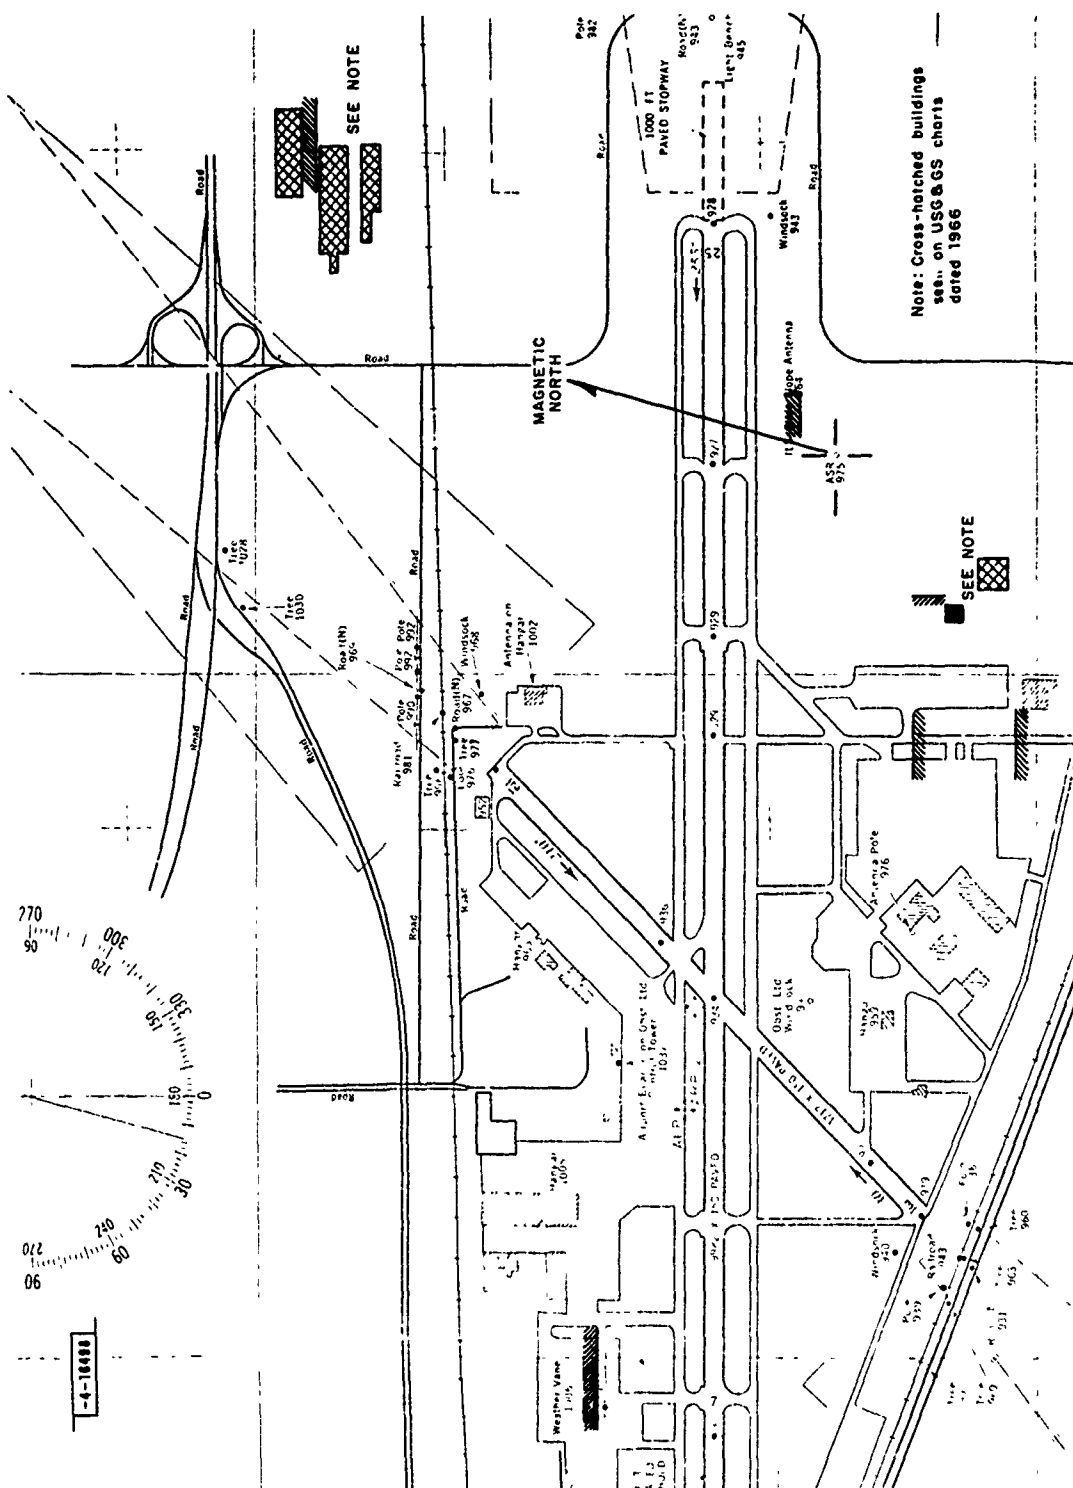
Fig. 15. Reflectors seen at Ontario, Calif. (conventional)

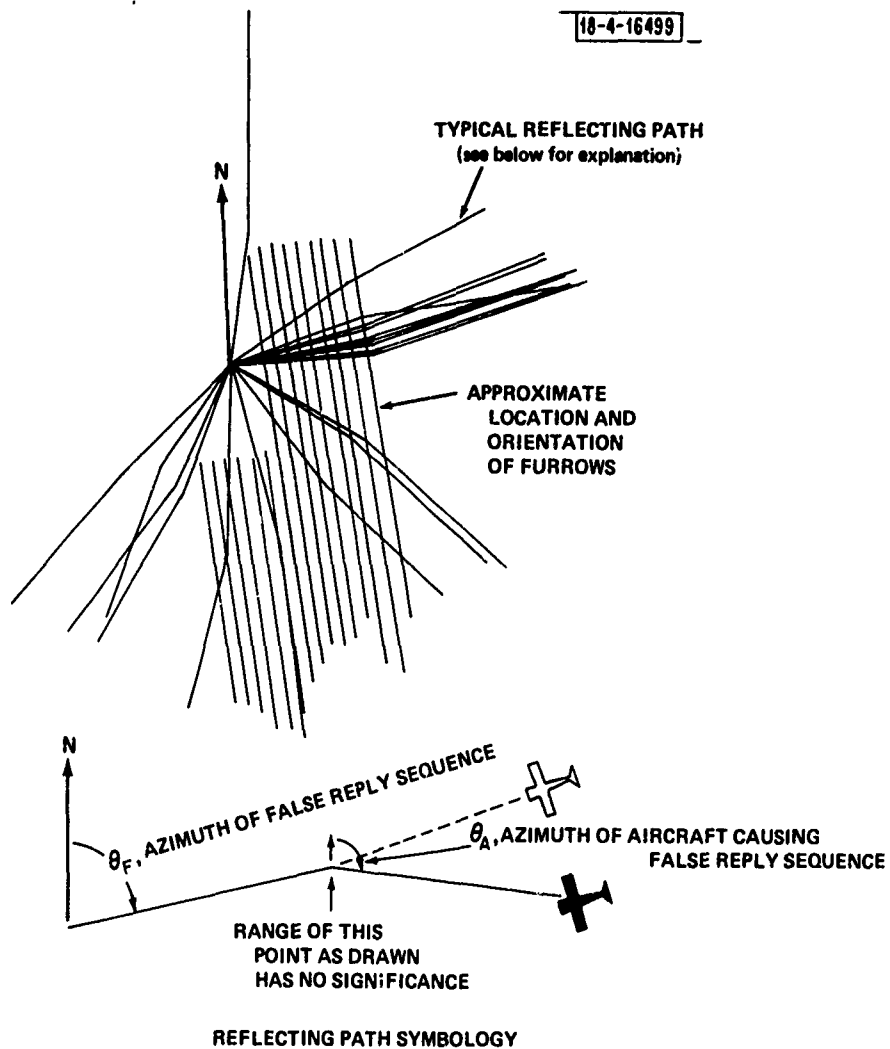
Fig. 16. Peculiar reflection geometry at Ontario.

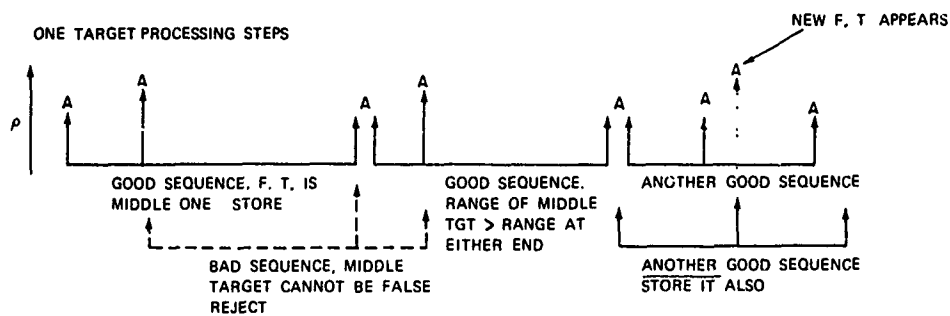
Fig. 19. Discrete-code false target processing.

- If the actual target is within the sidelobe reply range of the interrogator (say, eight miles), and more than one false target is noted at one or more azimuths, then put in "sidelobe" category.
- If in either of the above, put in "conventional" category.

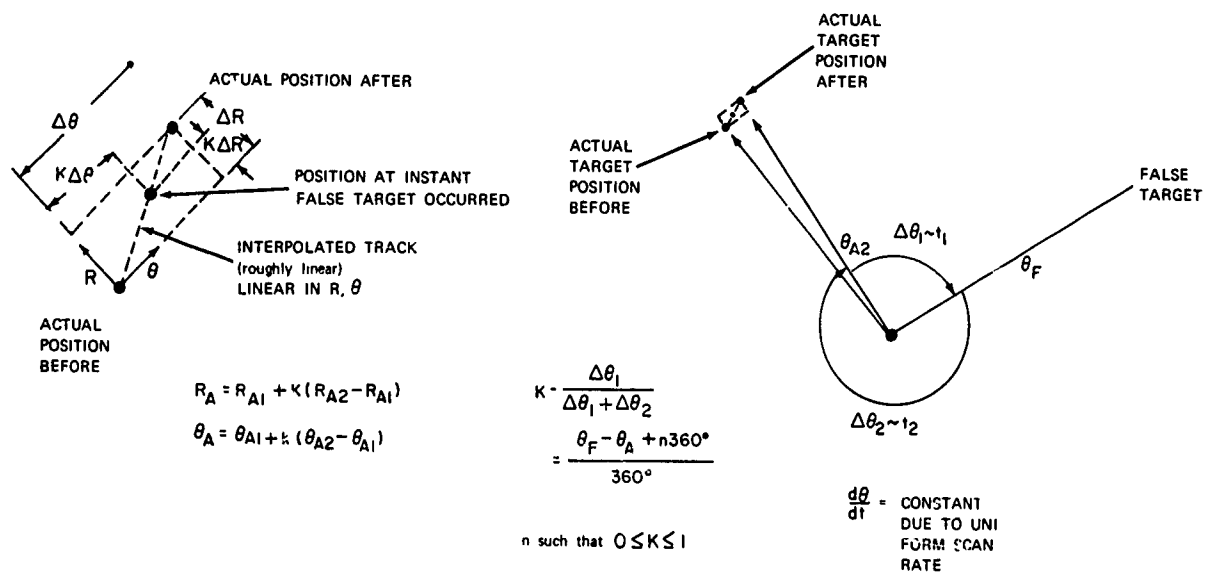
Fig. 21. Actual target position interpolation.

A highly precise estimate of that reflector's parameters could be obtained by averaging the parameters of the individual "samples". Accordingly, starting with the first reflector,  $\rho_R$ ,  $\theta_F$ , and  $\theta_O$  are examined for each. If any are within  $\pm 3^\circ$ ,  $\pm 0.25$  nmi, and  $1^\circ$  of the first reflector, a composite set of data are formed by averaging the parameters of the two. The length of the line representing the reflector could be modified by the amount of difference in  $\theta_R$ , to account for building length (in cases where length is comparable to a Fresnel zone, such that different portions of the building illuminate the aircraft at different locations on adjacent scans); line length will then serve as a crude representation of reflector extent. The process would continue down the list, updating the composite data whenever a new sample is within  $\pm 3^\circ$ ,  $\pm 0.25$  nmi. Note that this will require a running count of how many samples are included in the composite, in order to properly weigh new data.

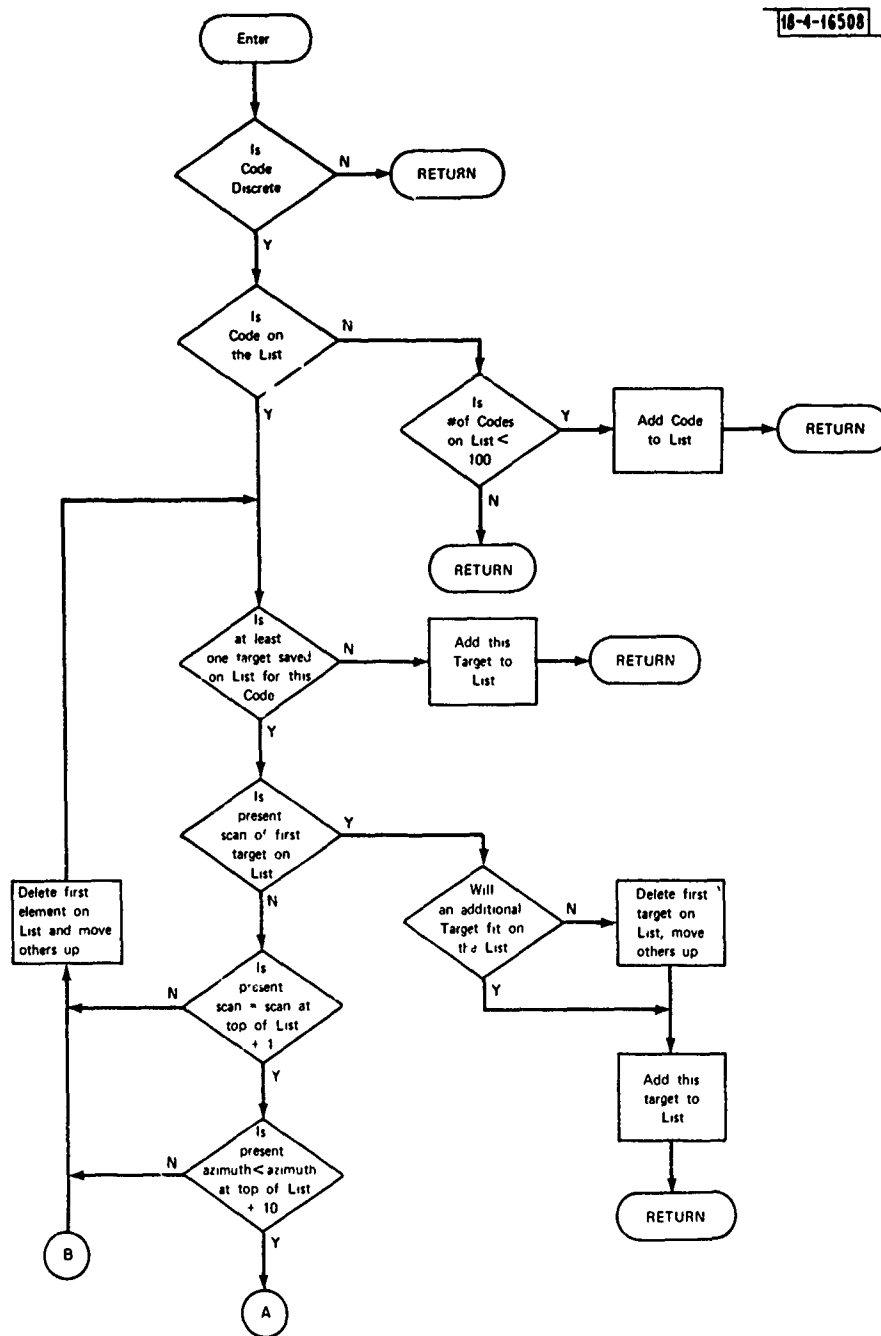
Fig. 25. Program flow chart\*.

Fig. 25. (continued).

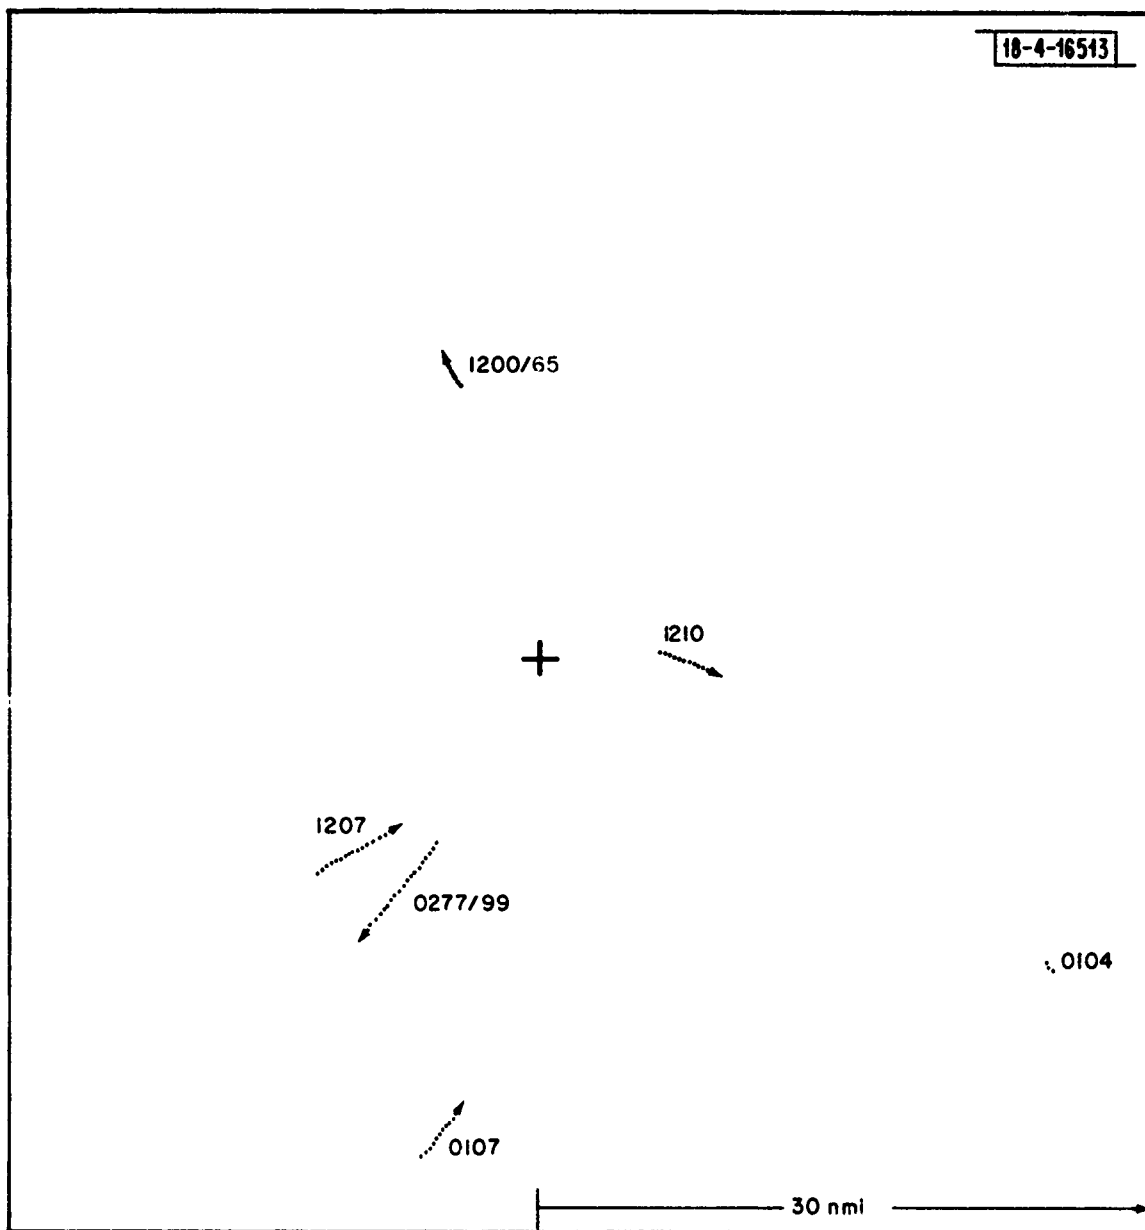
Fig. 31. Aircraft tracks - MSP scans 70-40.

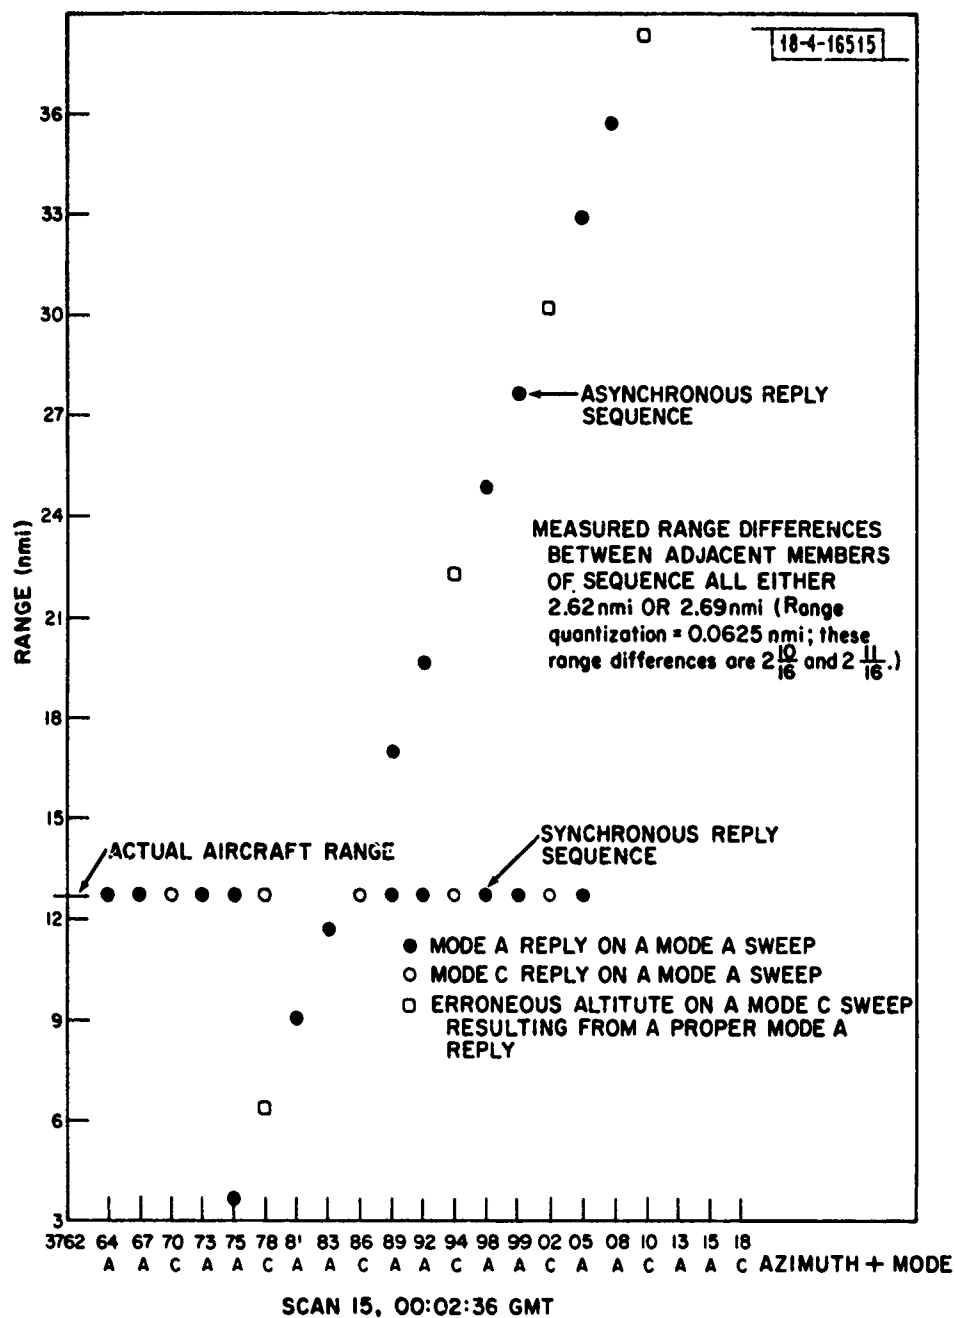
Each tick denotes a sweep. Numbers are the last two digits of the ACP.

Fig. 33. Fruit pattern - MSP.

Another point which is evident from Fig. 33 is worth mention. Note that on sweeps 81 and 83 the synchronous reply is suppressed, because the synchronous interrogation follows too closely after the interrogation of the ARSR. Similarly, on sweep 86 the fruit reply is suppressed because it follows

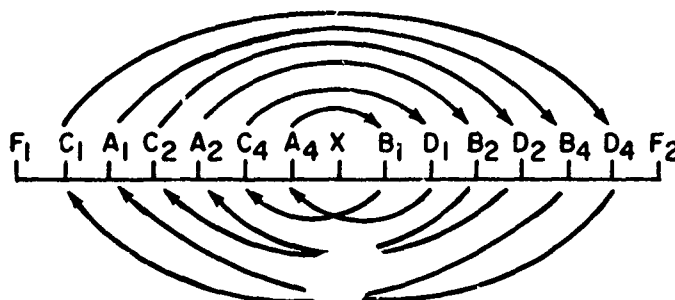
Fig. 36 Relationship between anomalous and legitimate reply pulses.

The pattern by which these pulses are related is shown in Fig. 36. The arrows point from the actual pulse which must be present in the original code to the incorrect pulse which it causes in the anomalous code; note that the relationship is non-reciprocal.

While the relationships among the pulses are certainly regular and consistent, it is apparent from the diagram that they cannot be explained by any simple mechanism which could be related to multipath phenomena such as a fixed delay, or a combination of delays. However, the manner in which a) D, A, B, and C pulses, respectively, cause anomalous A, B, C, and D pulses and, b) pulses 1, 2, and 4 cause anomalous pulses 4, 2, and 1 strikes a familiar note.

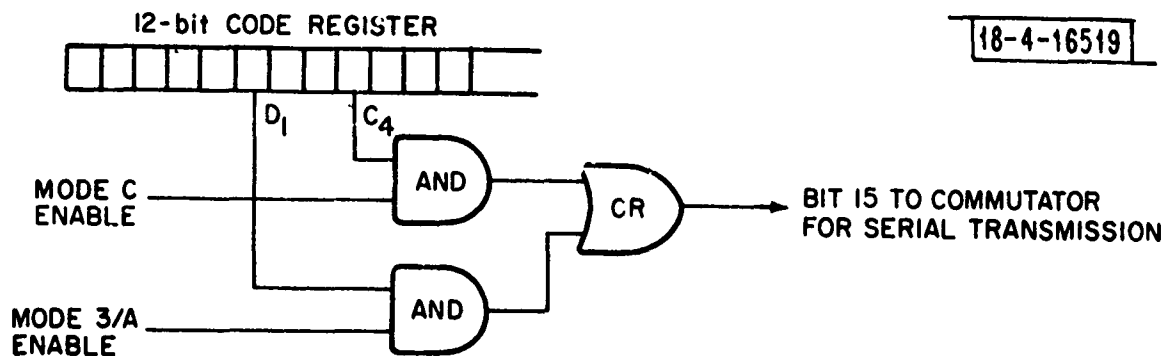
Fig. 37 ARTS III Reply Code Readout Circuitry

Given this fact, one can speculate with reasonable soundness on what is causing the anomalous codes in the Logan ARTS-III. The System Description manual [12] does not present detailed logic diagrams of the entire DAS, but does indicate in the DAS detailed block diagram (Fig. 3. 2-7) a functional unit (called the "Code Transformation Gates") which formats DAS reply words. That unit is hard-wired to read out the code bits in either of the above formats. Telephone conversations with Burroughs personnel reveal that circuitry of the sort shown in Fig. 37 (a simple "toggle") is employed (only the circuitry for bit #15 is shown for clarity):

The enable lines are driven by a set of flip-flops, which are set at the beginning of each sweep, and reset by the maximum range pulses. Any improper enabling signal on the wrong enable line would allow the  $C_4$  bit (if present) to pass the and-gate, and appear in bit position 15 (where the  $D_1$  pulse would be expected in a mode 3/A data word). Intermittent existence of such an enabling signal would cause intermittent presence of an anomalous pulse in the  $D_1$  (or any other) position of a mode 3/A reply word whenever the  $C_4$  pulse (or whatever pulse in the mode C line of the above table corresponded to that particular position) was present. This is precisely the behaviour that was displayed in the data.
